CHARACTERISTIC FAILURES OF TUNNELS

Michael J. Kavvadas

*Associate Professor of Civil Engineering
National Technical University of Athens, Greece*

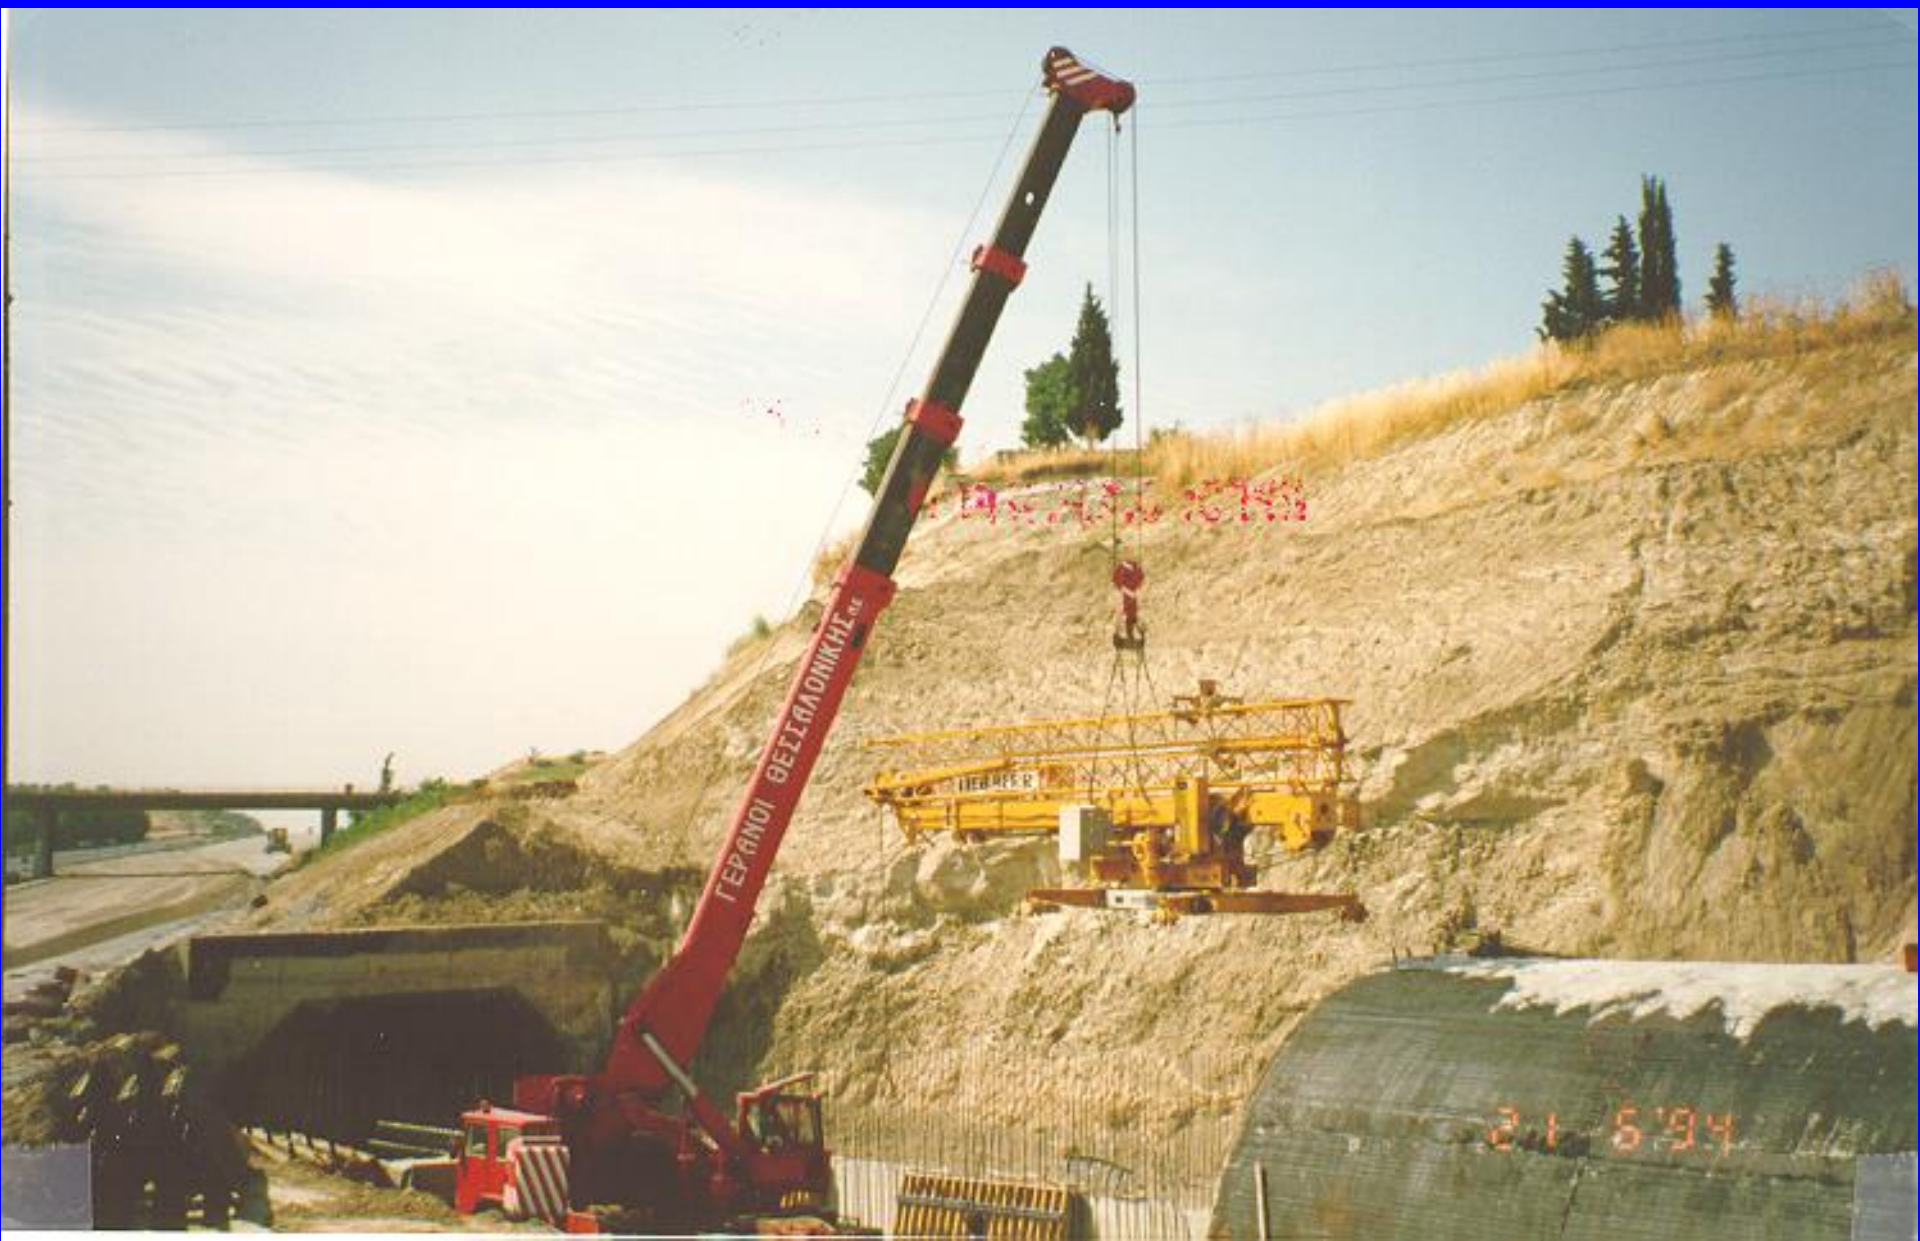
Railroad cut+cover in Methoni. Construction in June 1994
Slope consists of a stiff calcareous clay and is stable (1:1)

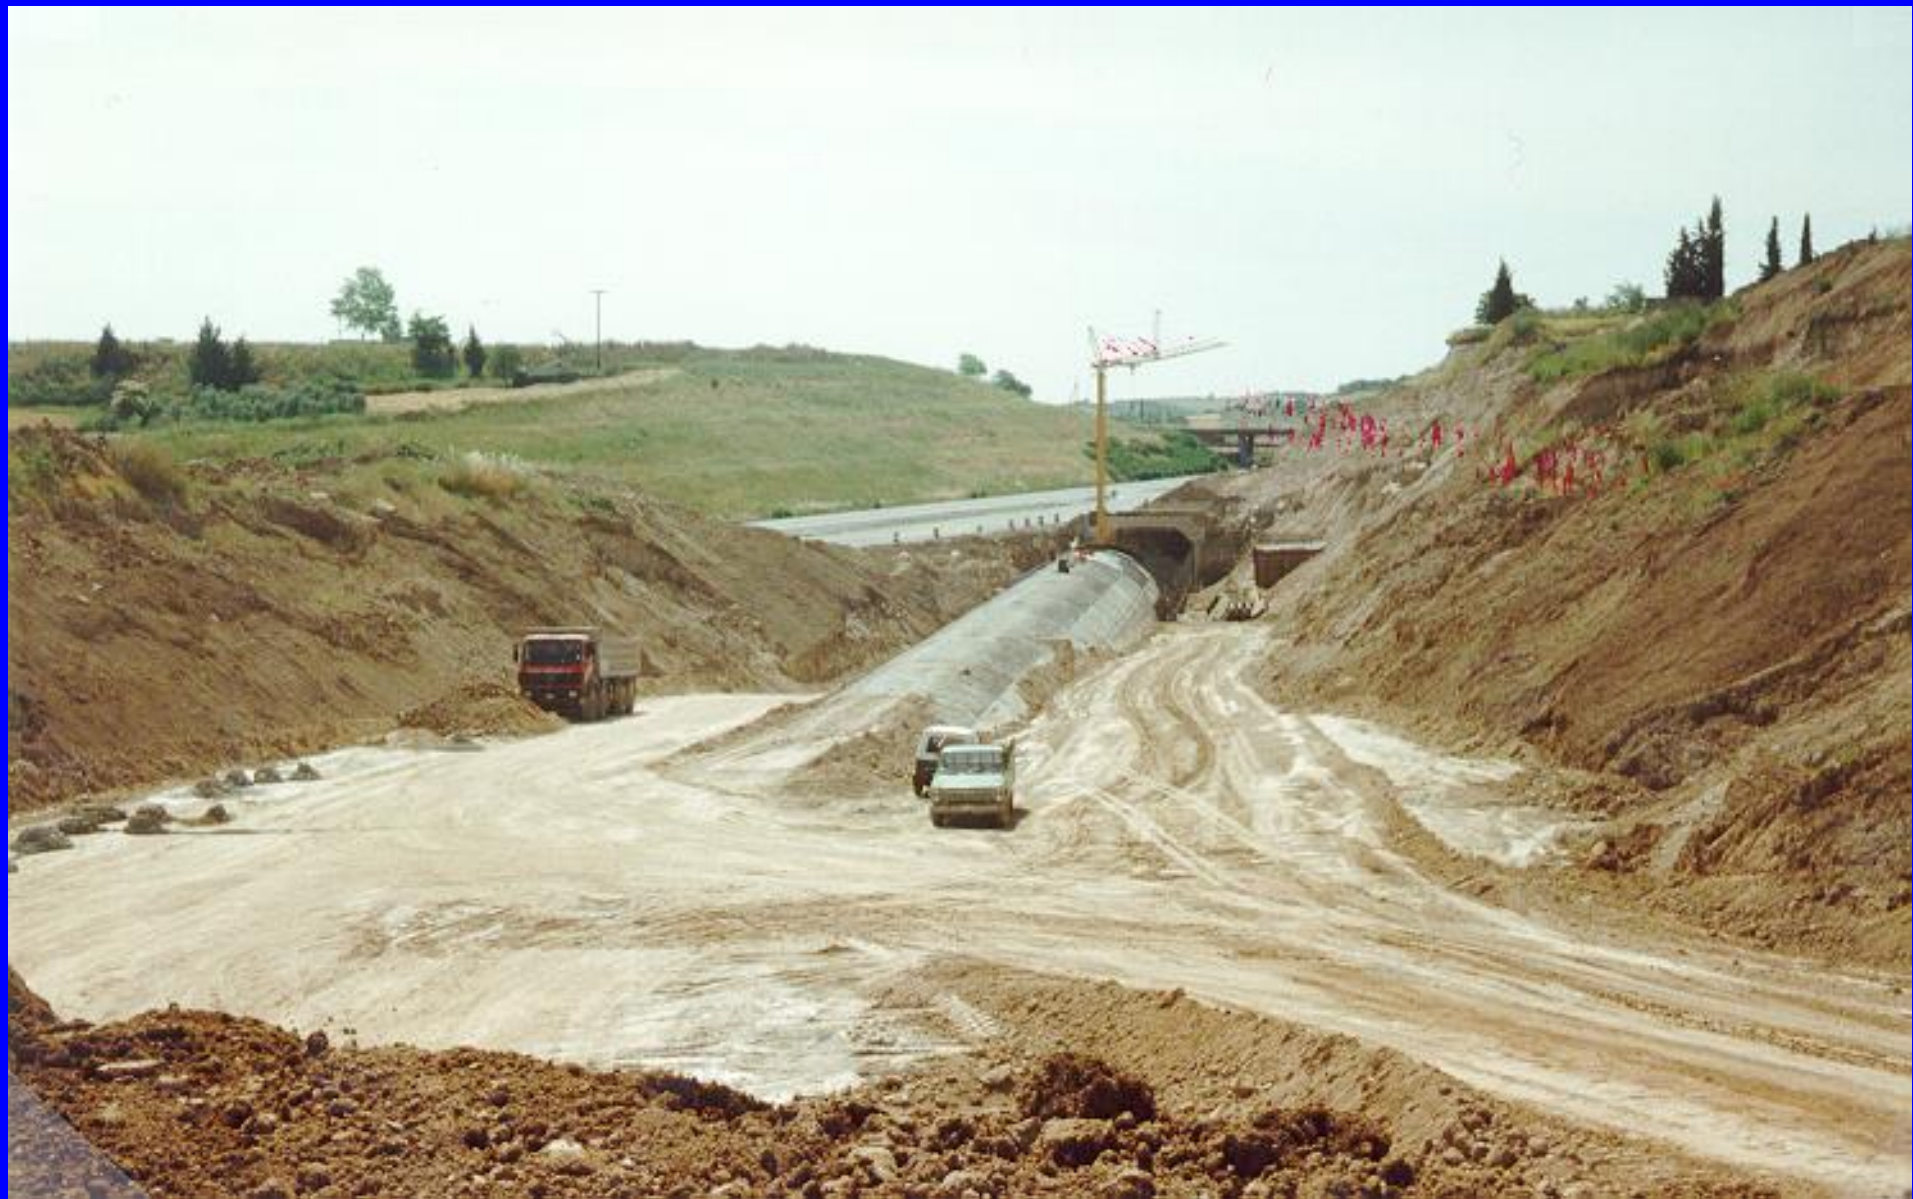
Railroad cut+cover in Methoni. Construction in June 1994
Slope consists of a stiff calcareous clay and is stable (1:1)

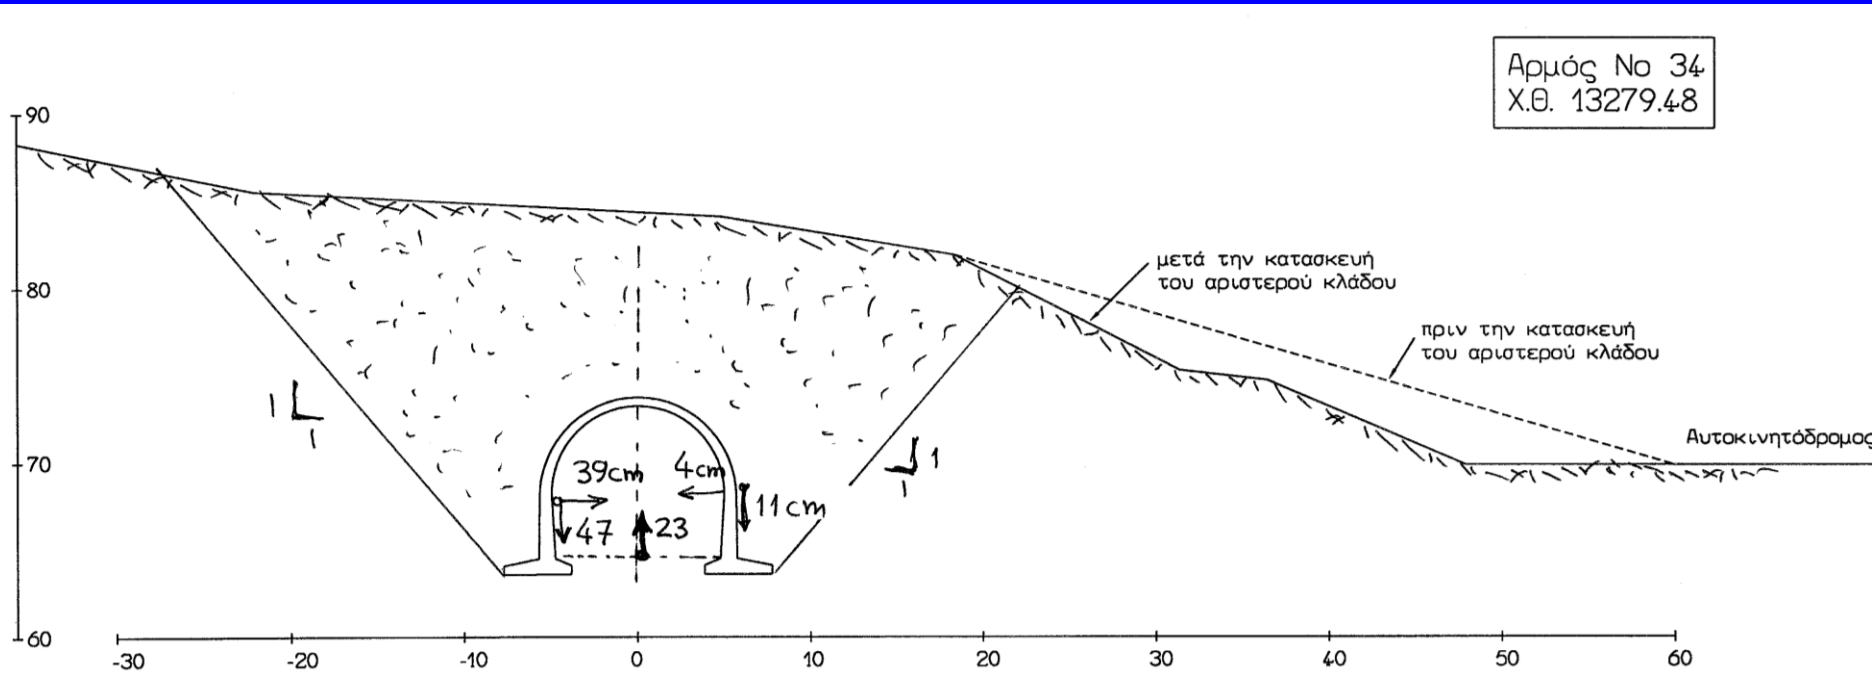
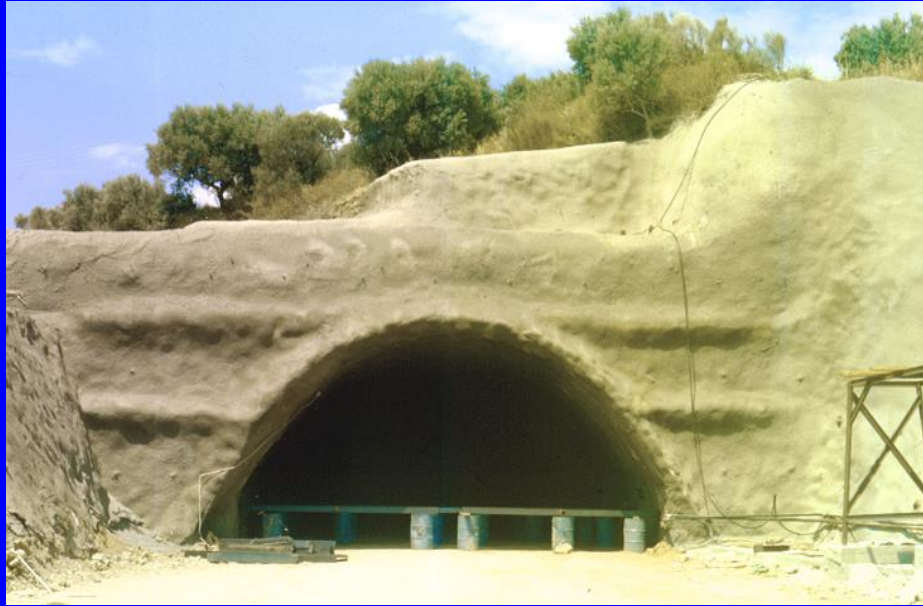
Railroad cut+cover in Methoni

- Significant movements were observed in the winter of 1996-97.
- It is believed that they are associated with a creep-type deformation of the slope triggered by the widening of the highway (1994-95)
- The cut+cover has to be re-constructed

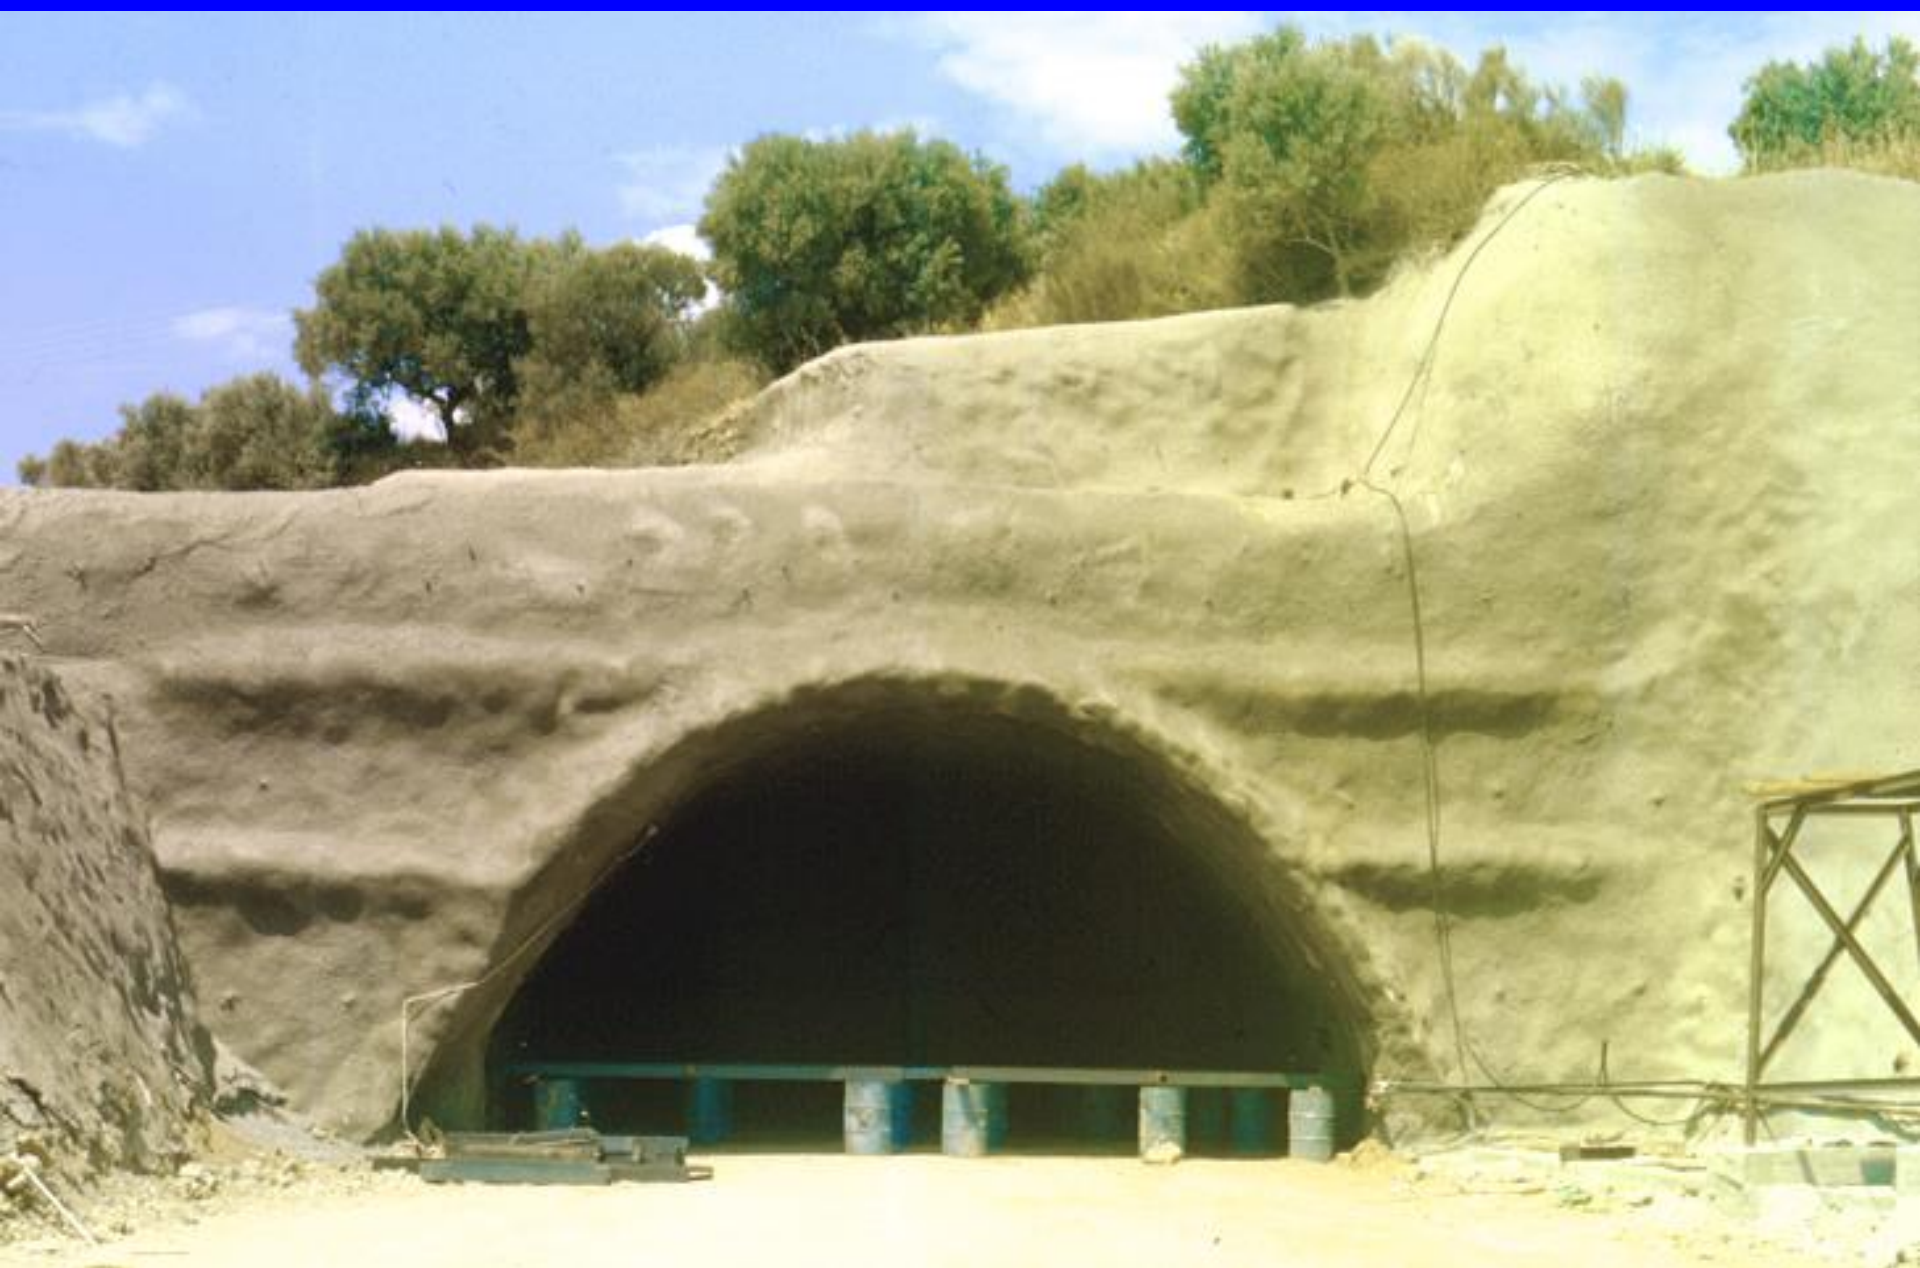
Patra by-pass road tunnel - *South portal before failure - August 1998*

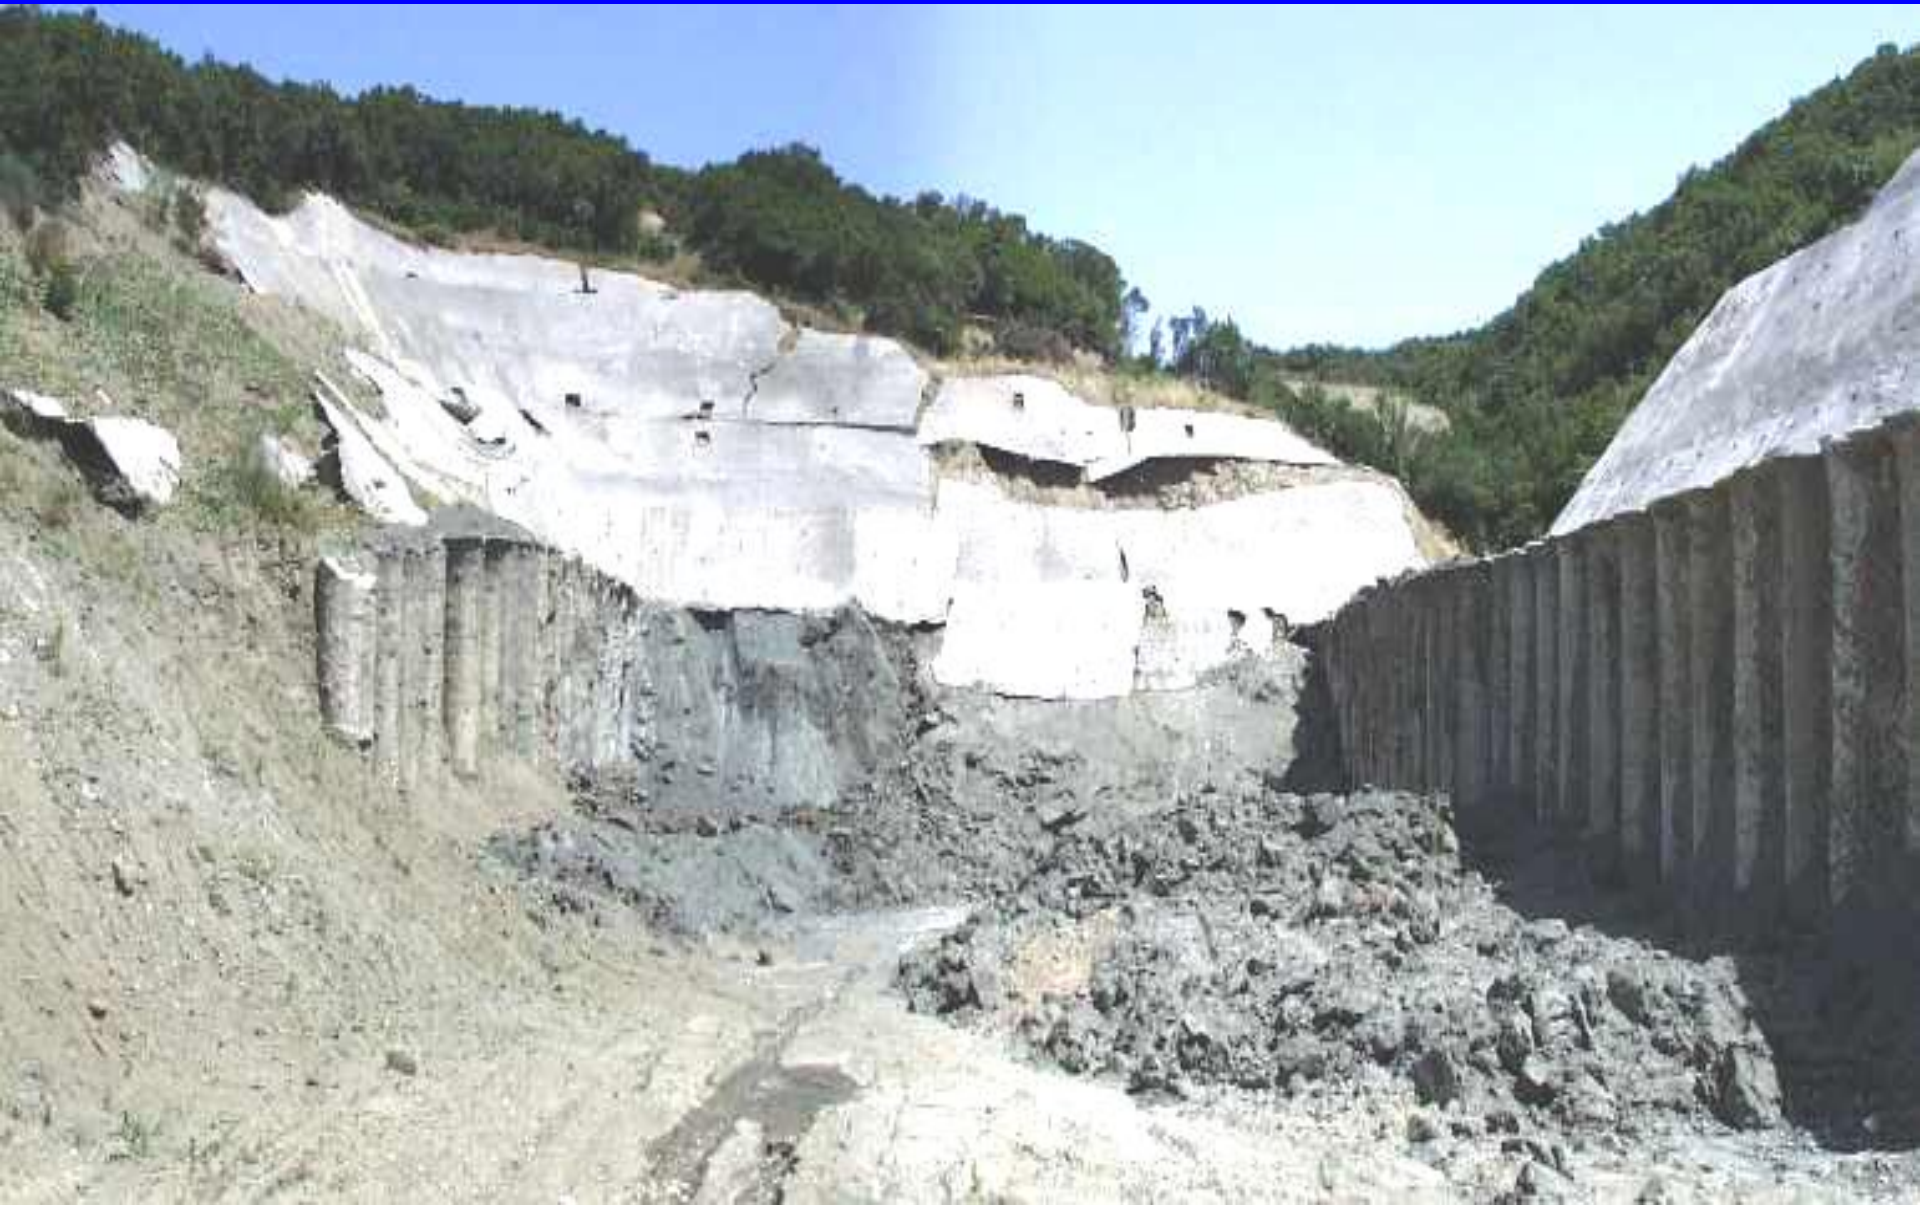
Egnatia Highway – Tunnel S2, west portal failure (summer 2000)

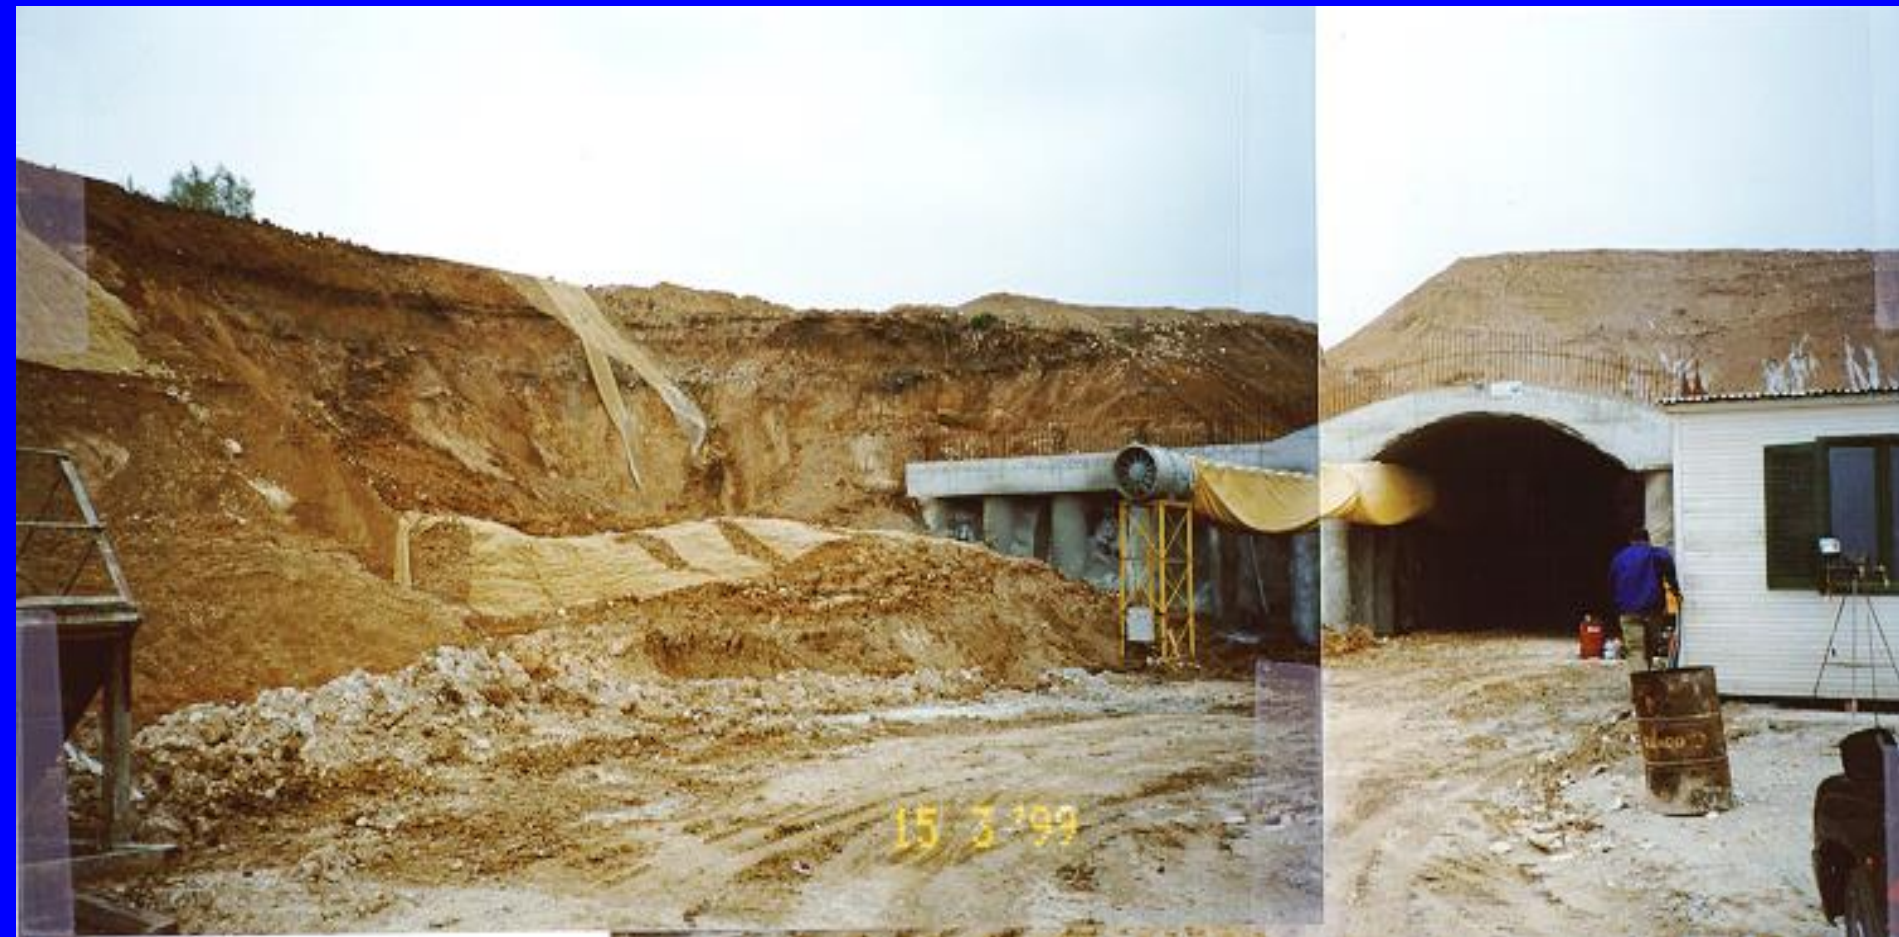
Kallidromon railway tunnel. South portal in Pleistocene deposits.

Slump-type instability of the left slope, due to water seeping from a nearby stream

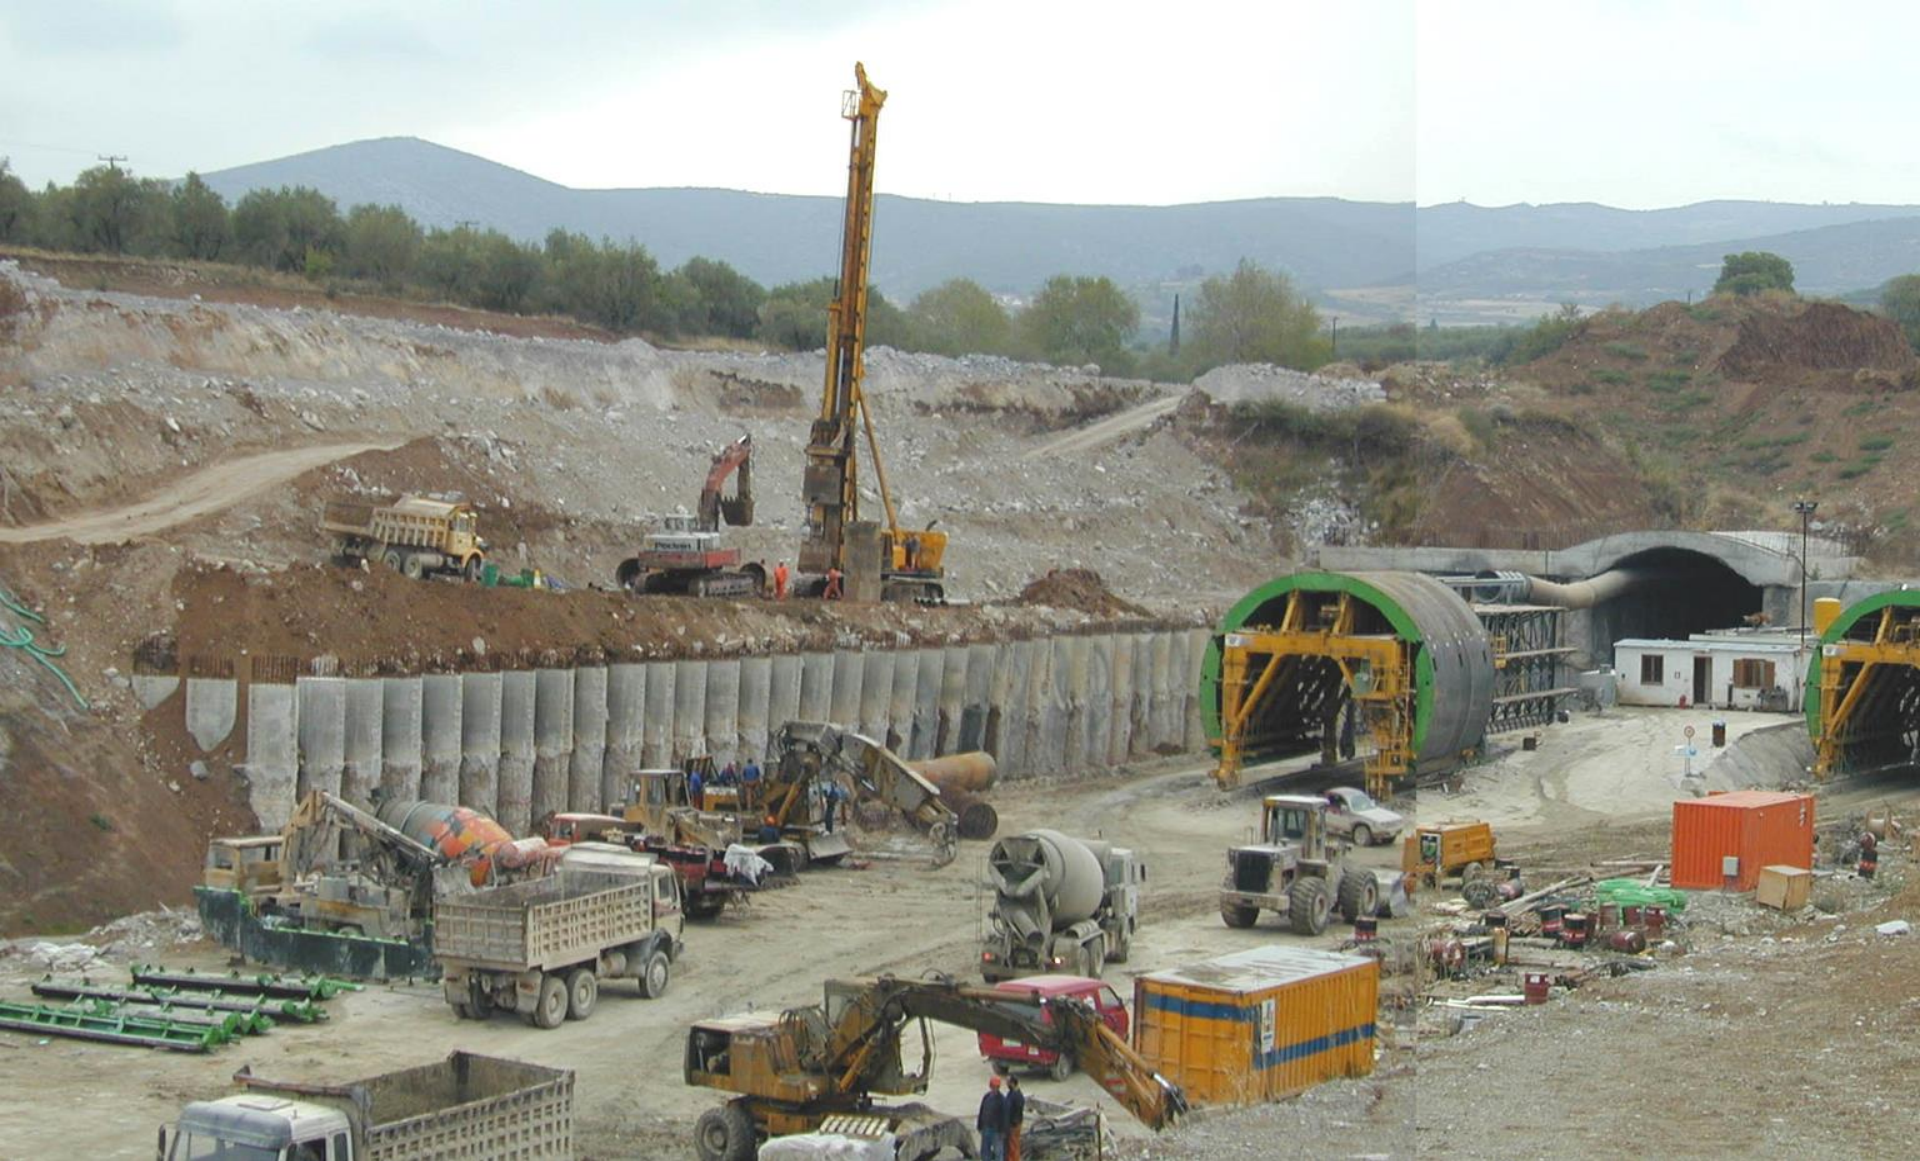
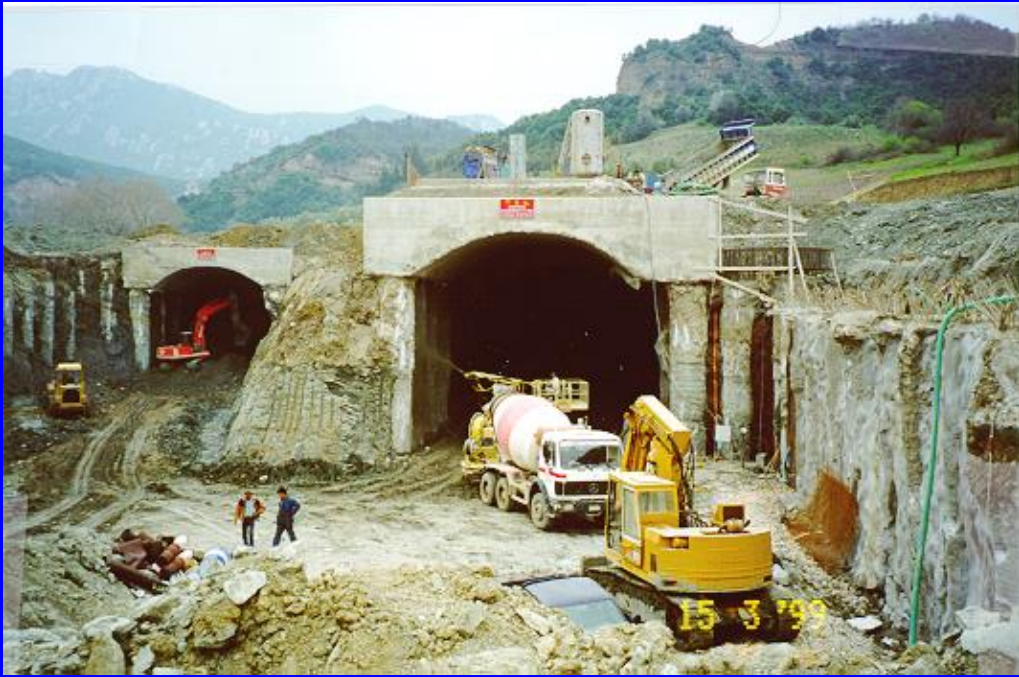
Kallidromon railway tunnel. South portal in Pleistocene deposits

Slump-type instability of the left slope, due to water seeping from a nearby stream

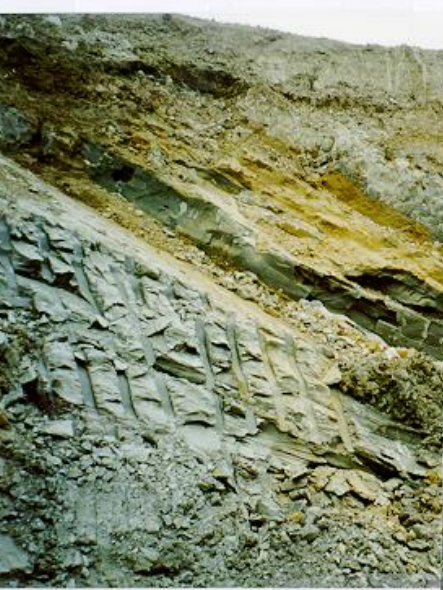
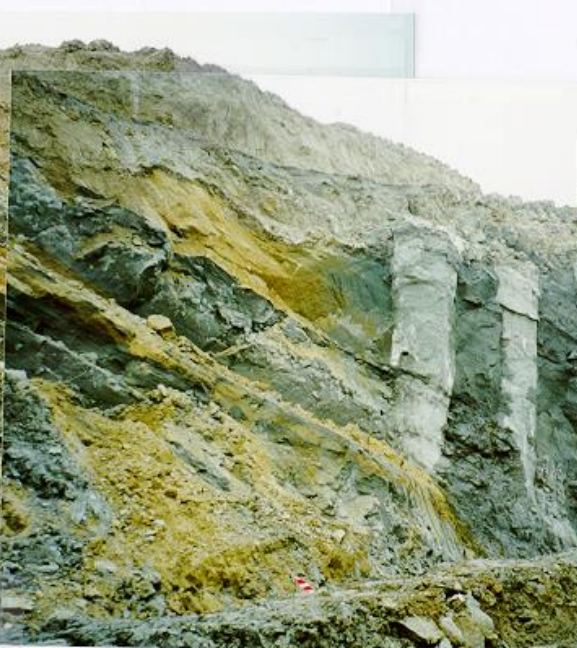
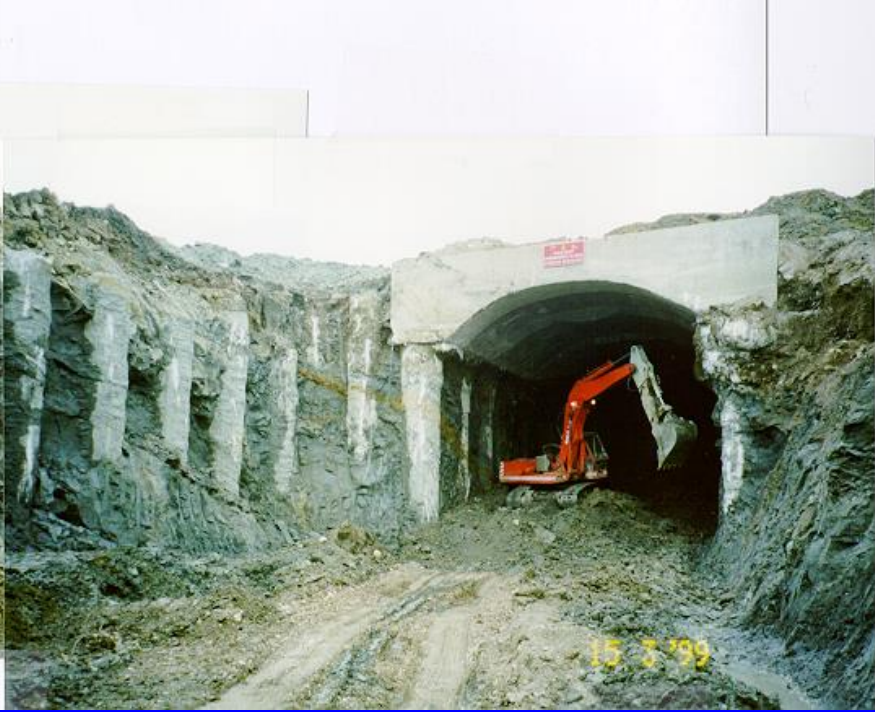
Kallidromon railway tunnel
North portals in stiff Pliocene clay.
The inclination of the bedding planes
causes instability of the left slope,
while the right slope is stable

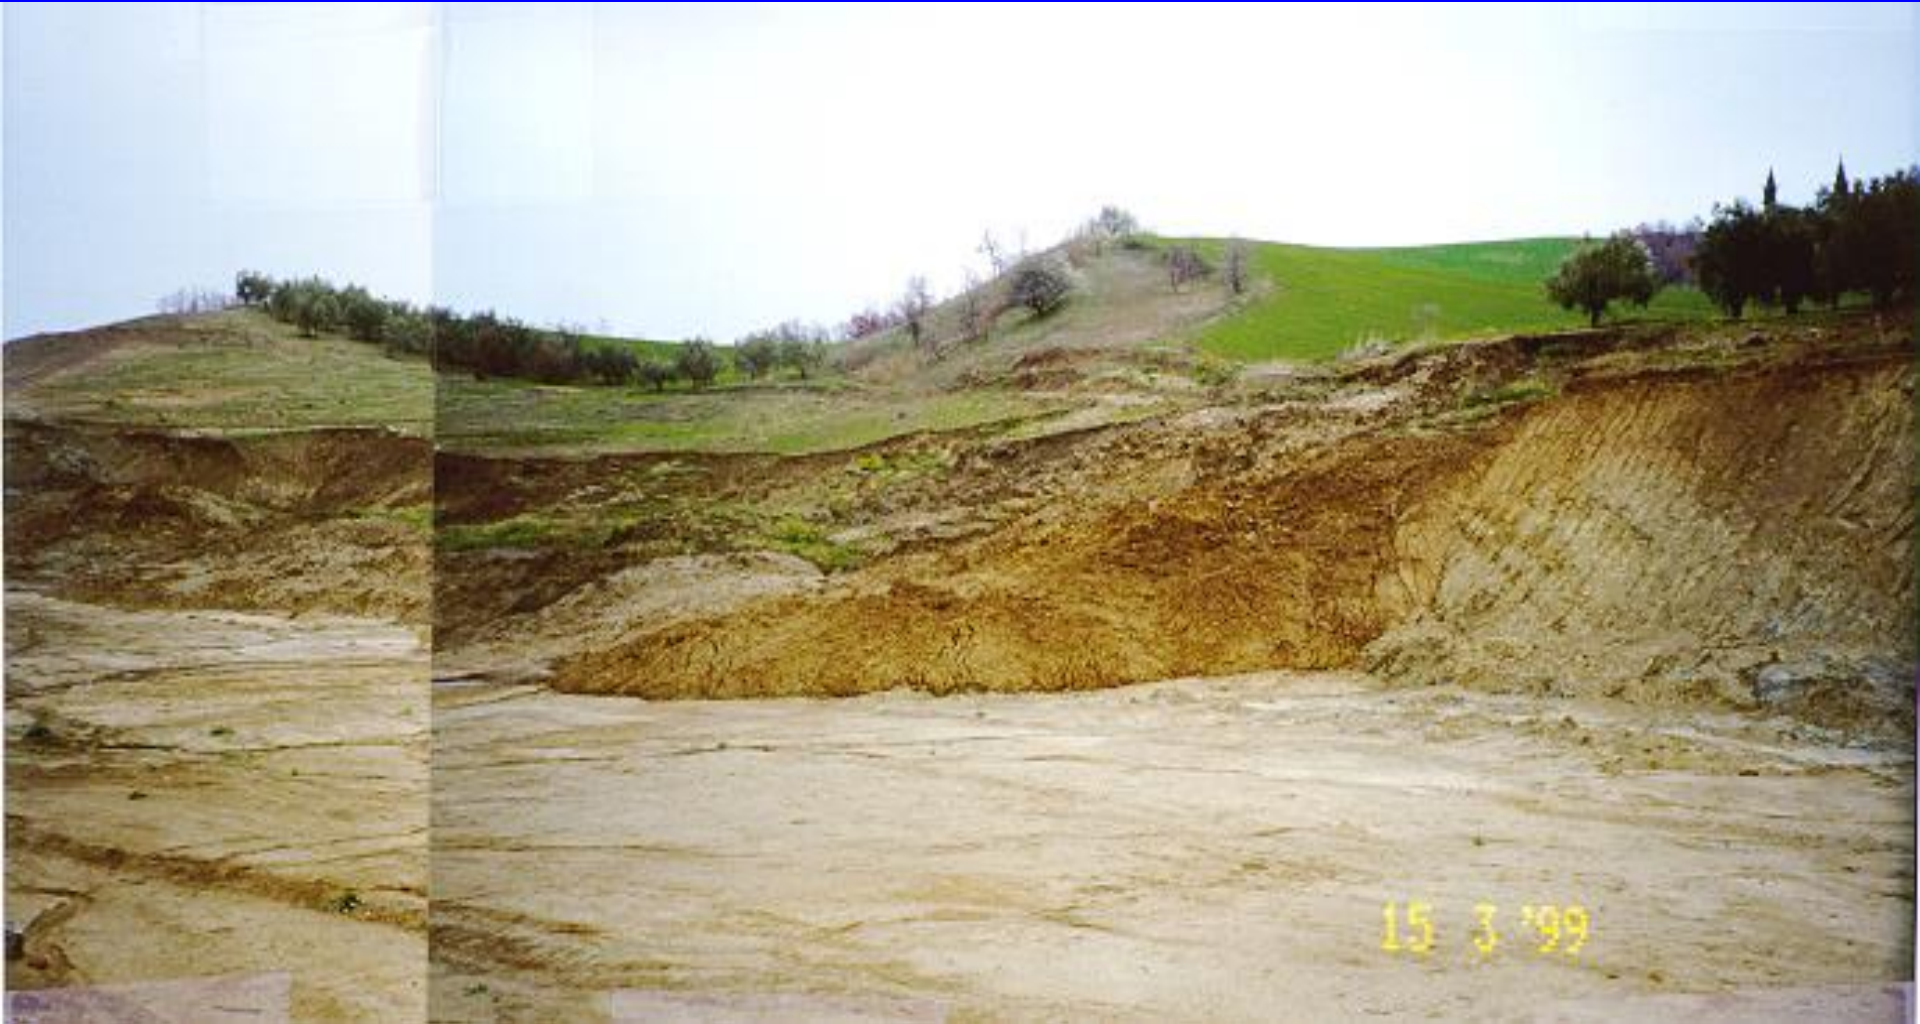
Kallidromon railway tunnel. North portal area

Slump-type slope failure (h=3m) in stiff Pliocene clay

The design calls for a 15m cut with slope inclination 2:3 (v:h)

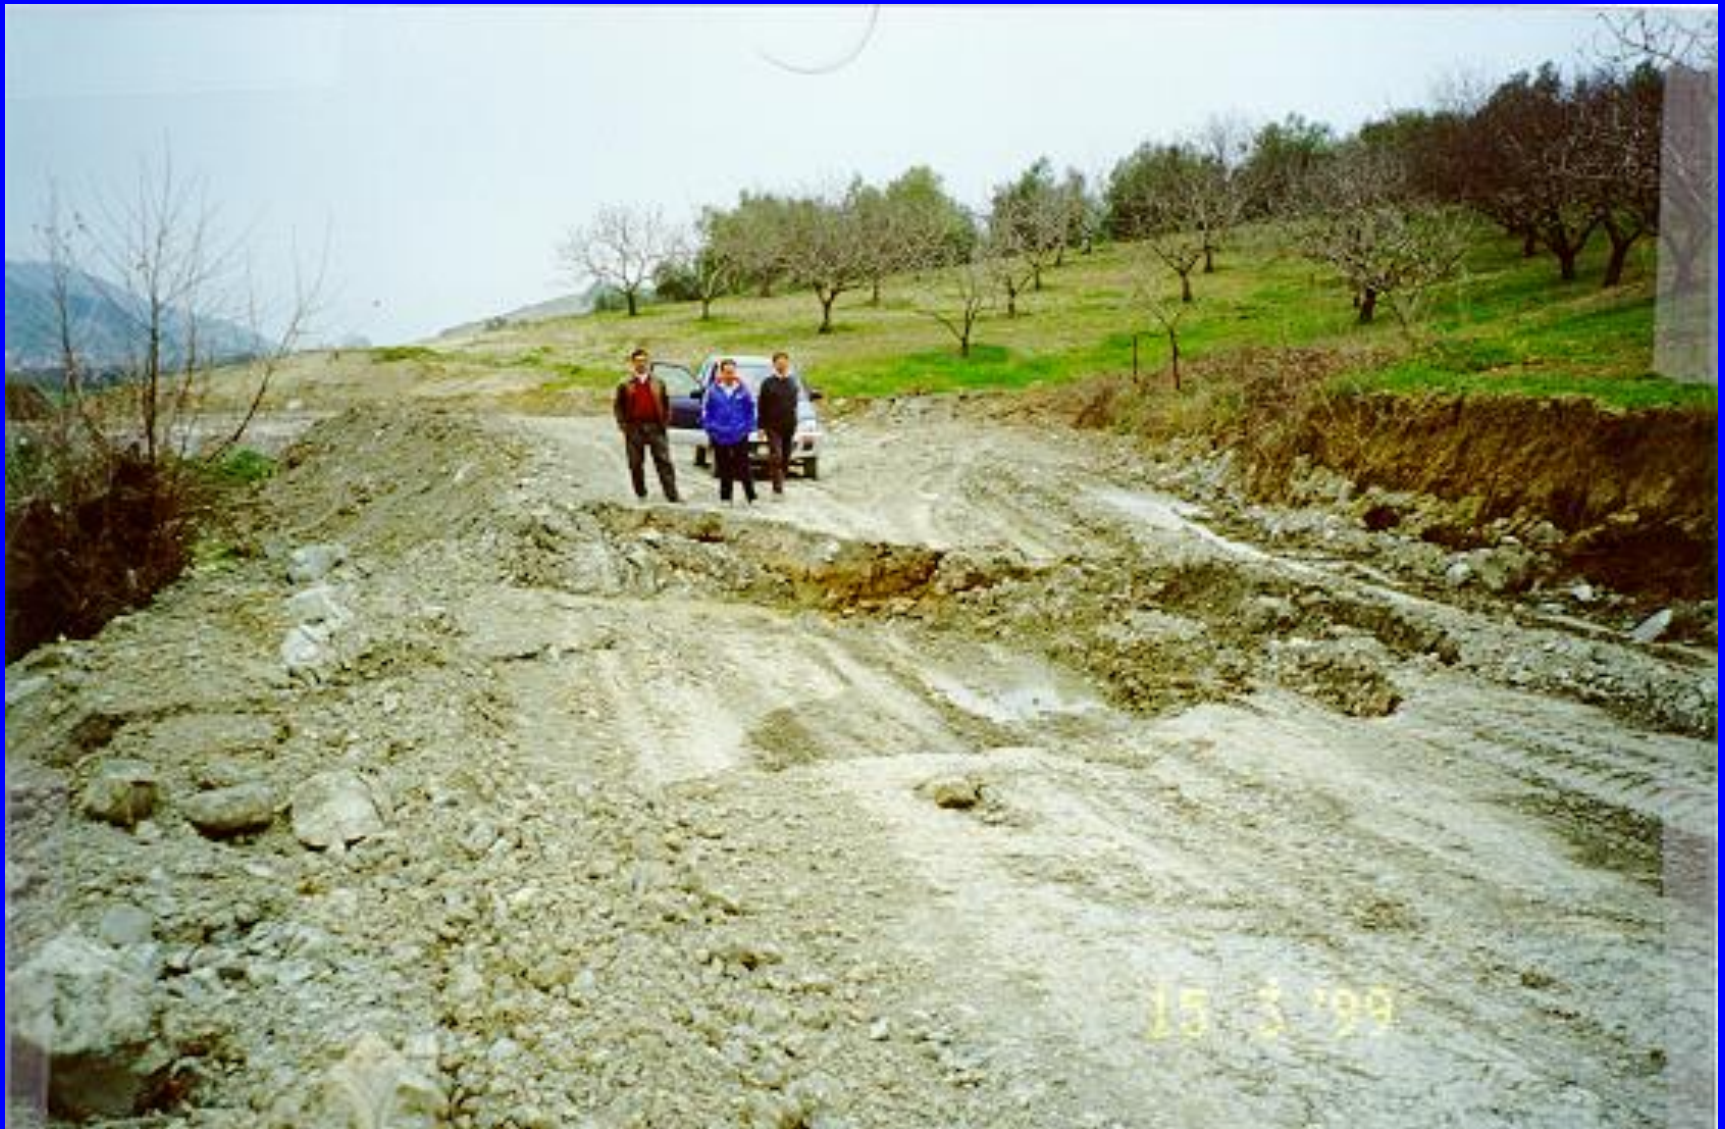
Kallidromon railway tunnel. North portal area

Embankment slope failure (h=3m) in stiff Pliocene clay

The design calls for a 15m cut with slope inclination 2:3 (v:h)
