CHARACTERISTIC FAILURES OF TUNNELS

Michael J. Kavvadas

*Associate Professor of Civil Engineering
National Technical University of Athens, Greece*

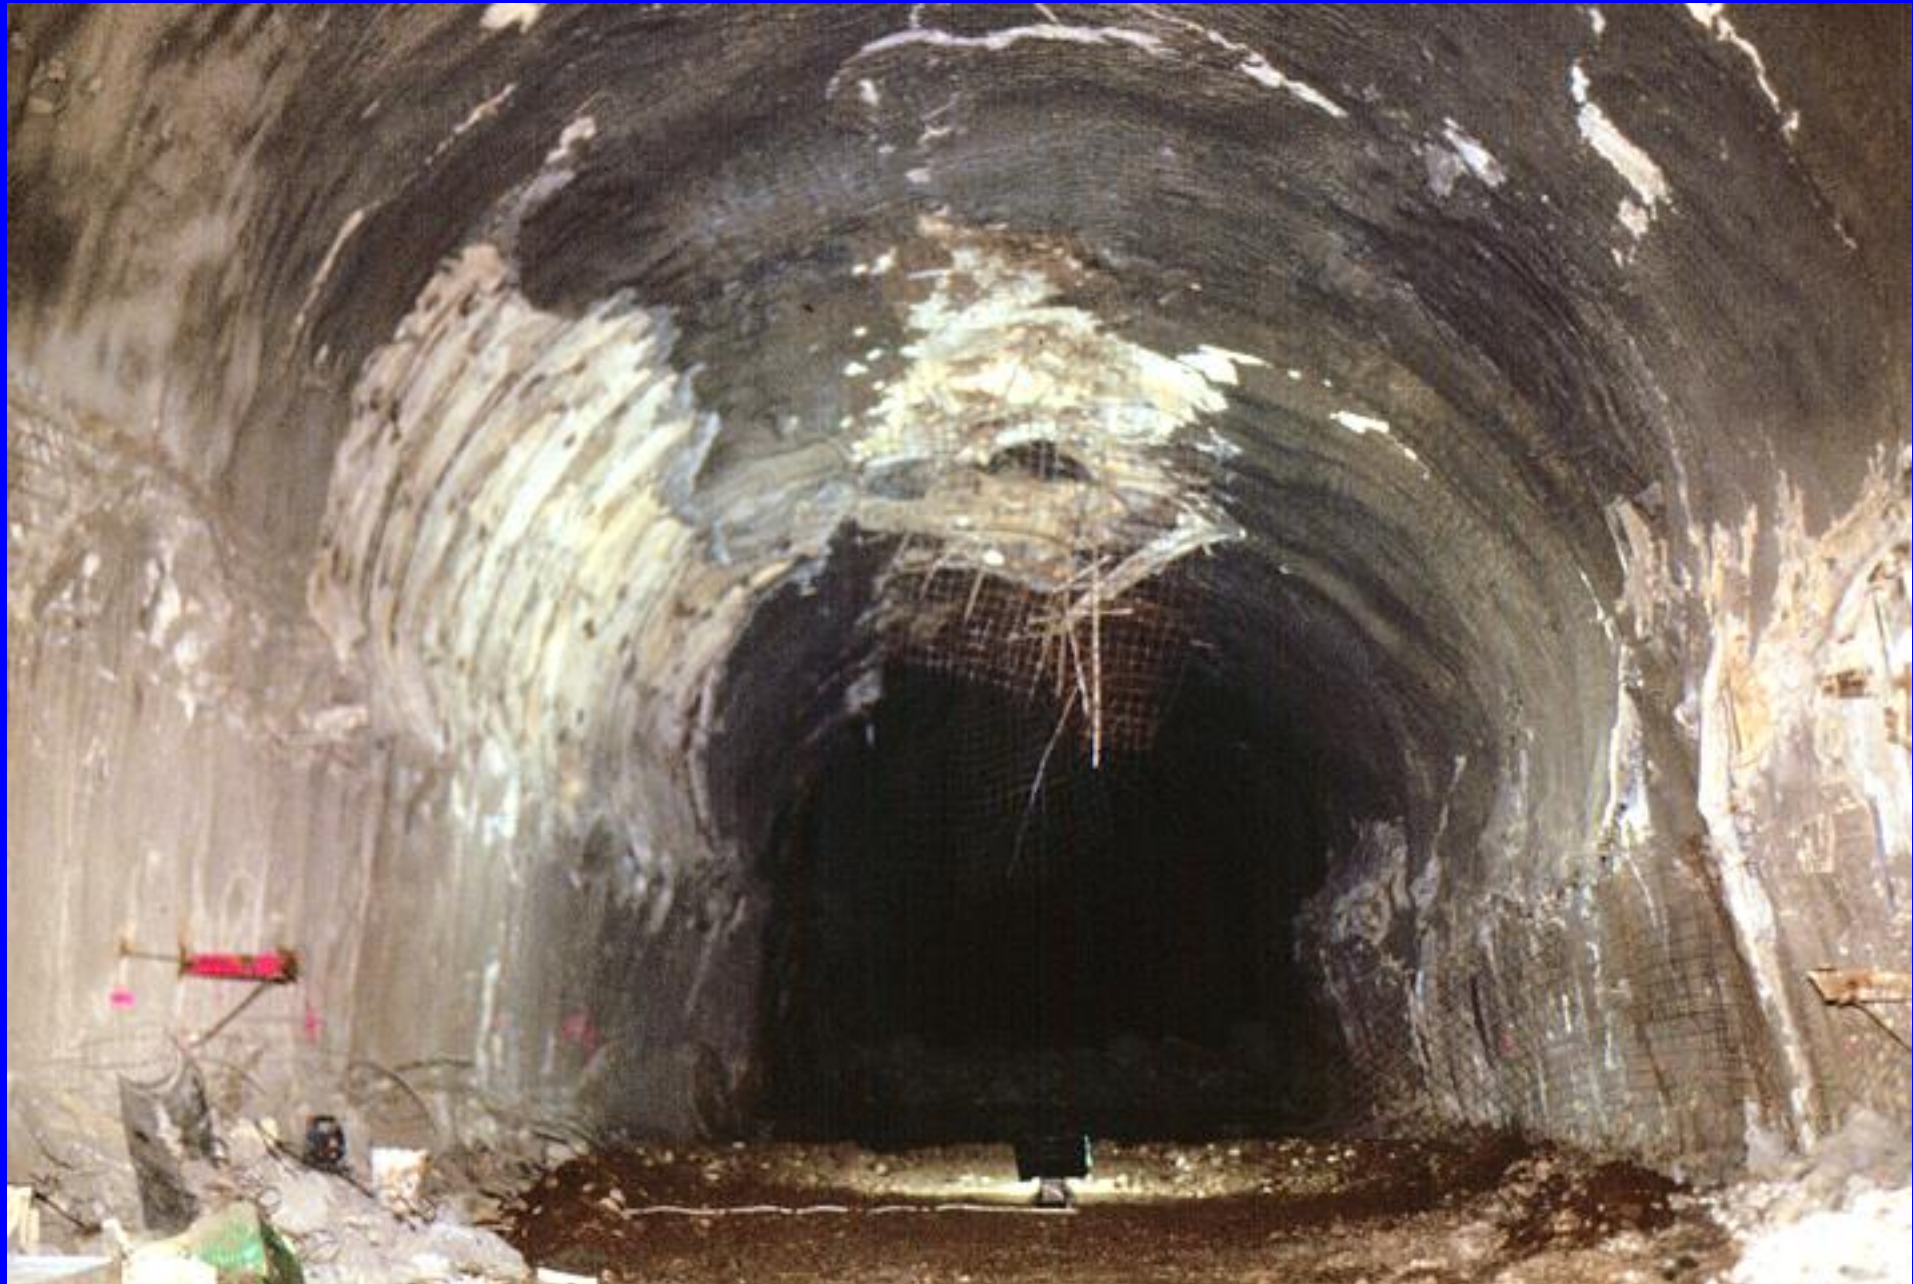
Tymfristos road tunnel in flysch. Wall convergence reached 2 m.

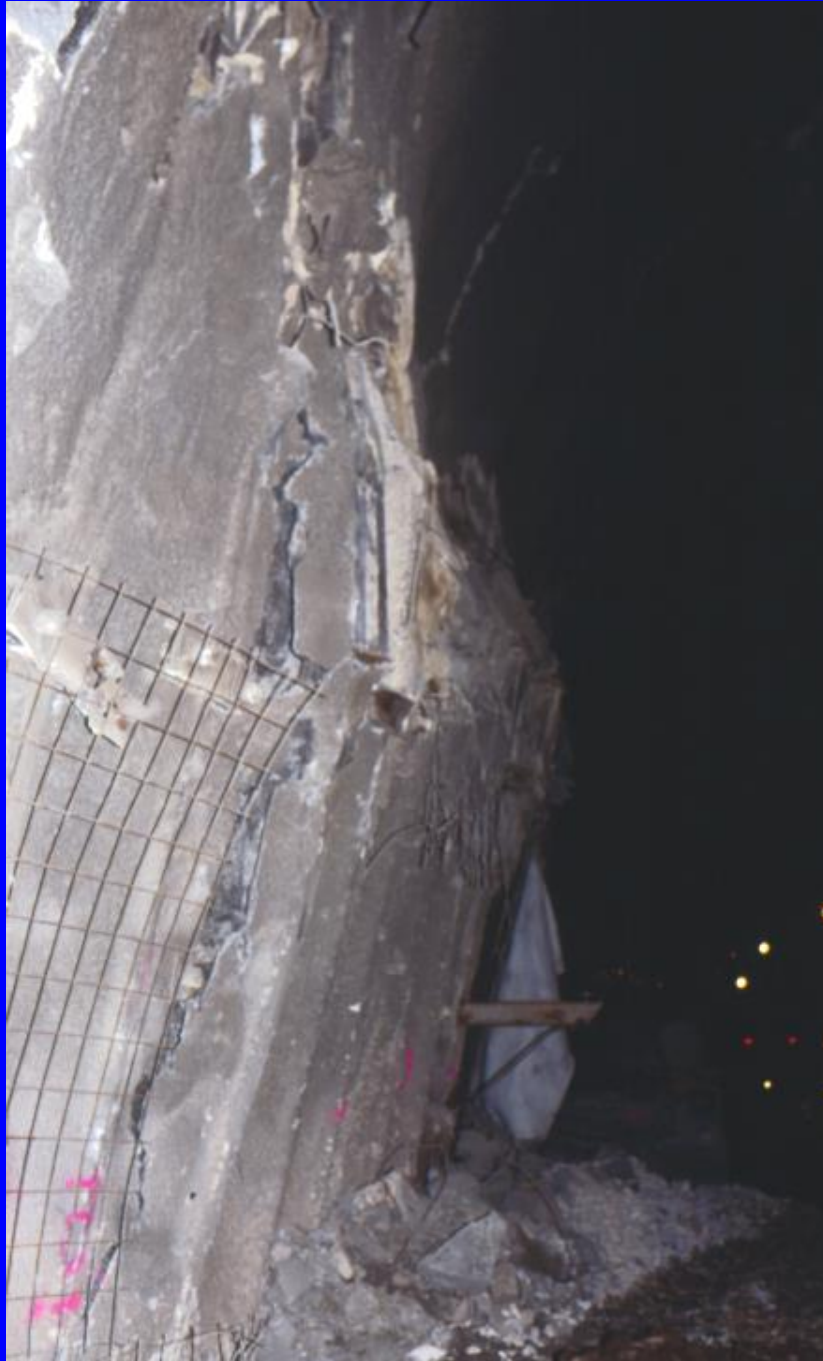
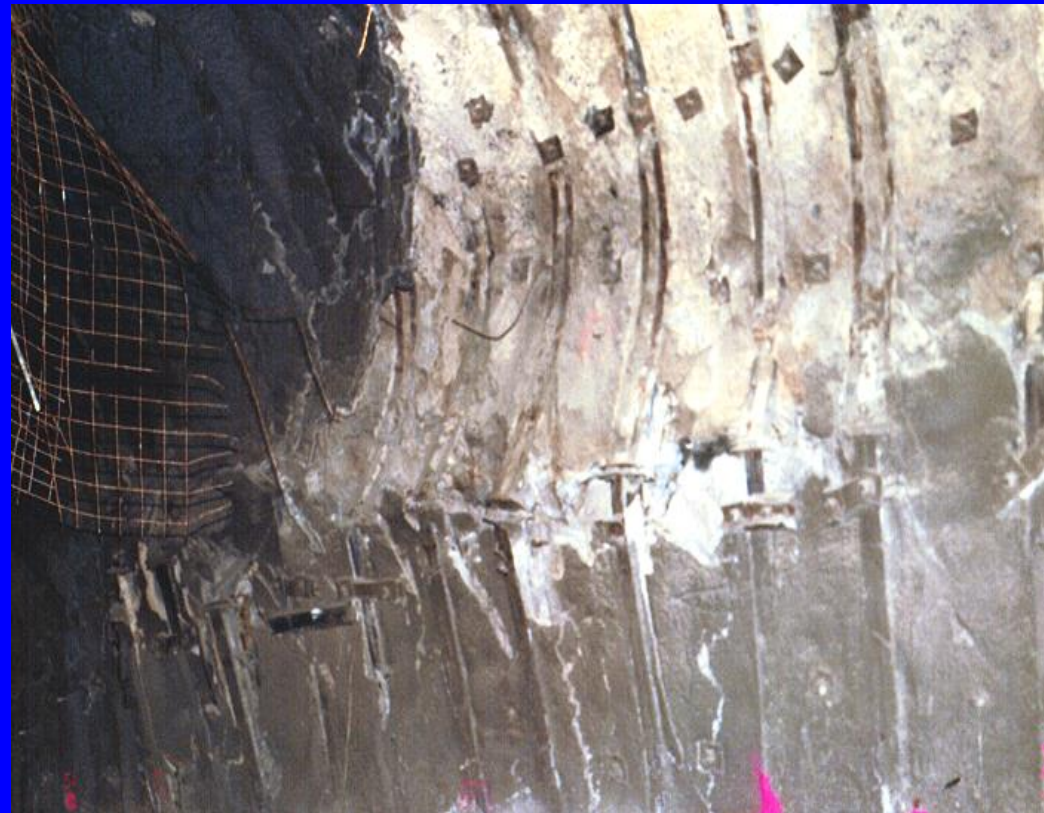
Tymfristos road tunnel in flysch

- Wall convergence reached 2 m, and the tunnel had to be re-mined
- Rock bolts were too short (4m) and were installed during the week-end, for scheduling reasons

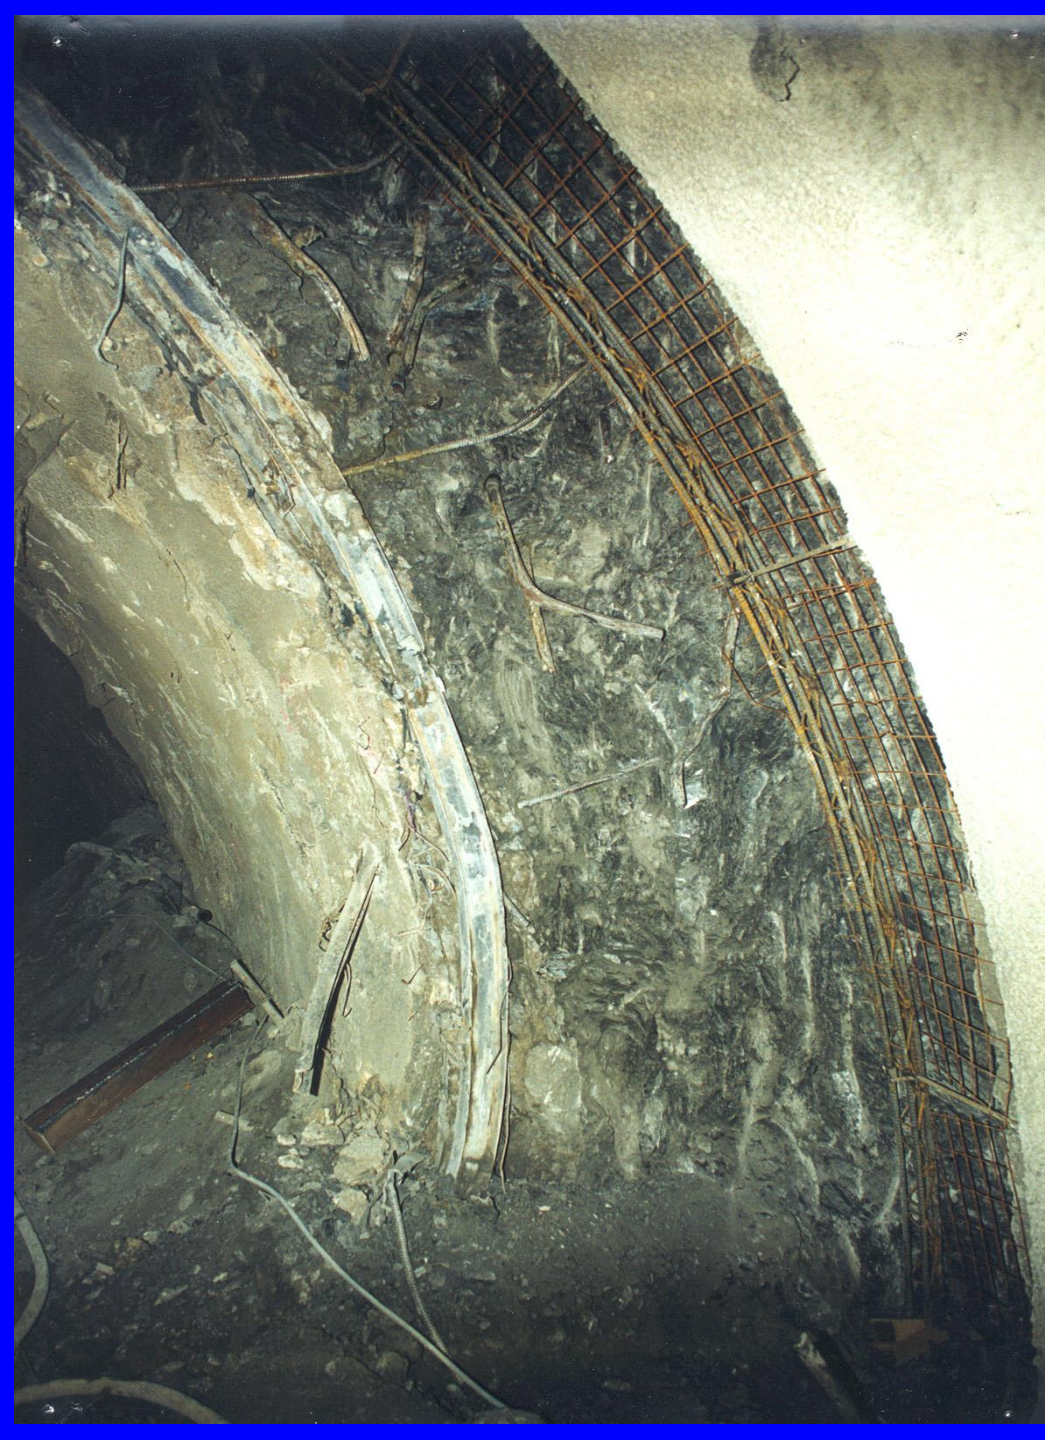
Failures in tunneling :
Tymphristos highway tunnel
in flysch

Re-mining of section with
large wall convergence
