Differential Settlement and Induced Structural Damage in a Cut-and-Cover Subway Tunnel in a Soft Deposit

Εφαρμογή: Πόσο μειώνεται η φέρουσα ικανότητα της σήραγγας λόγω της σχετικής υποχώρησης κατά δ σε μήκος L ;

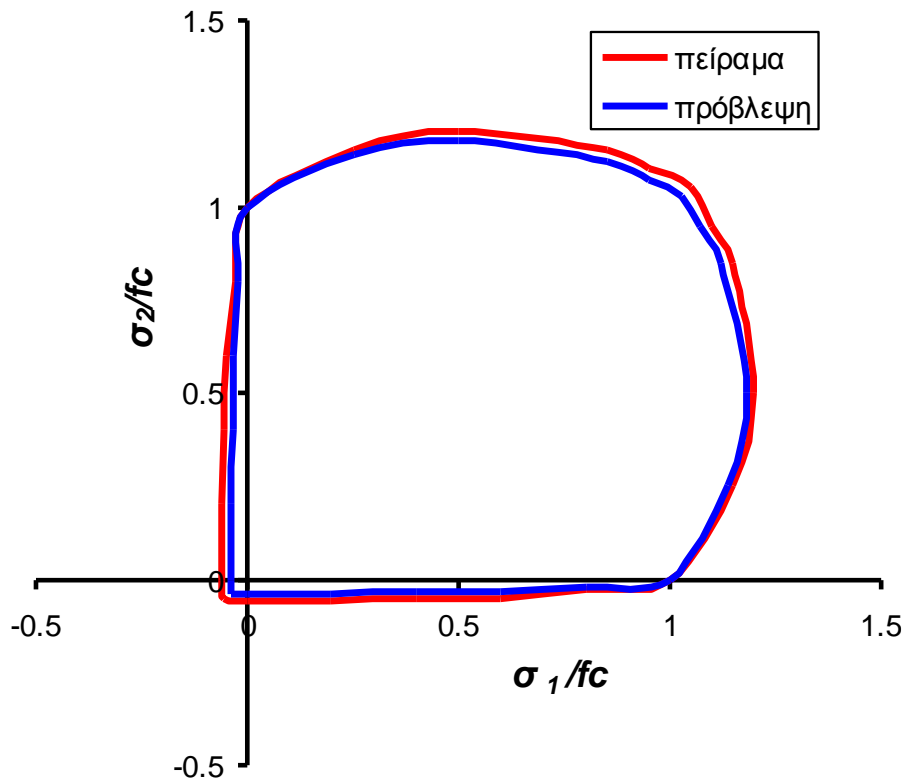
Καμπύλη αντοχής σκυροδέματος υπό διαξονική ένταση

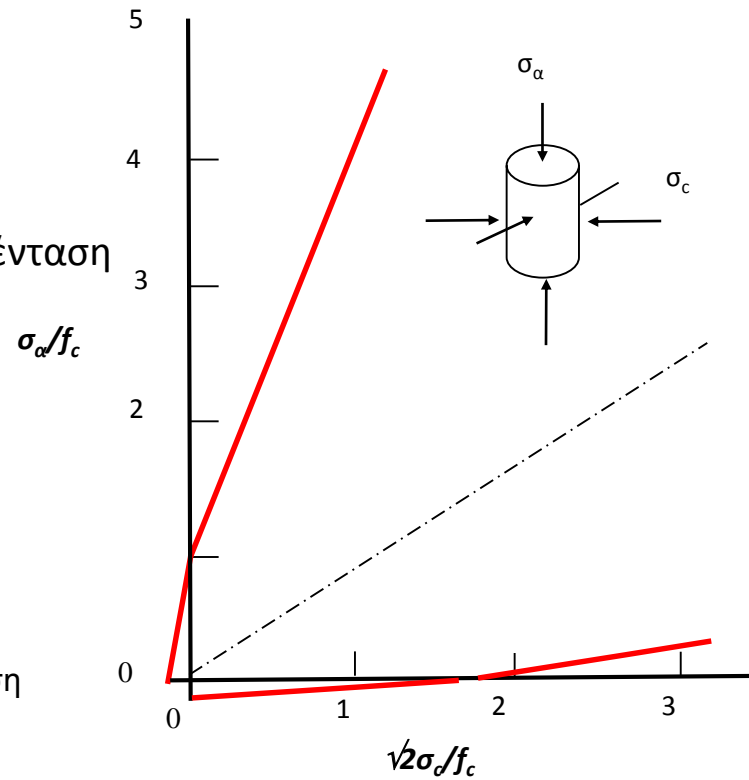
Αντοχή σκυροδέματος υπό αξονοσυμμετρική ένταση

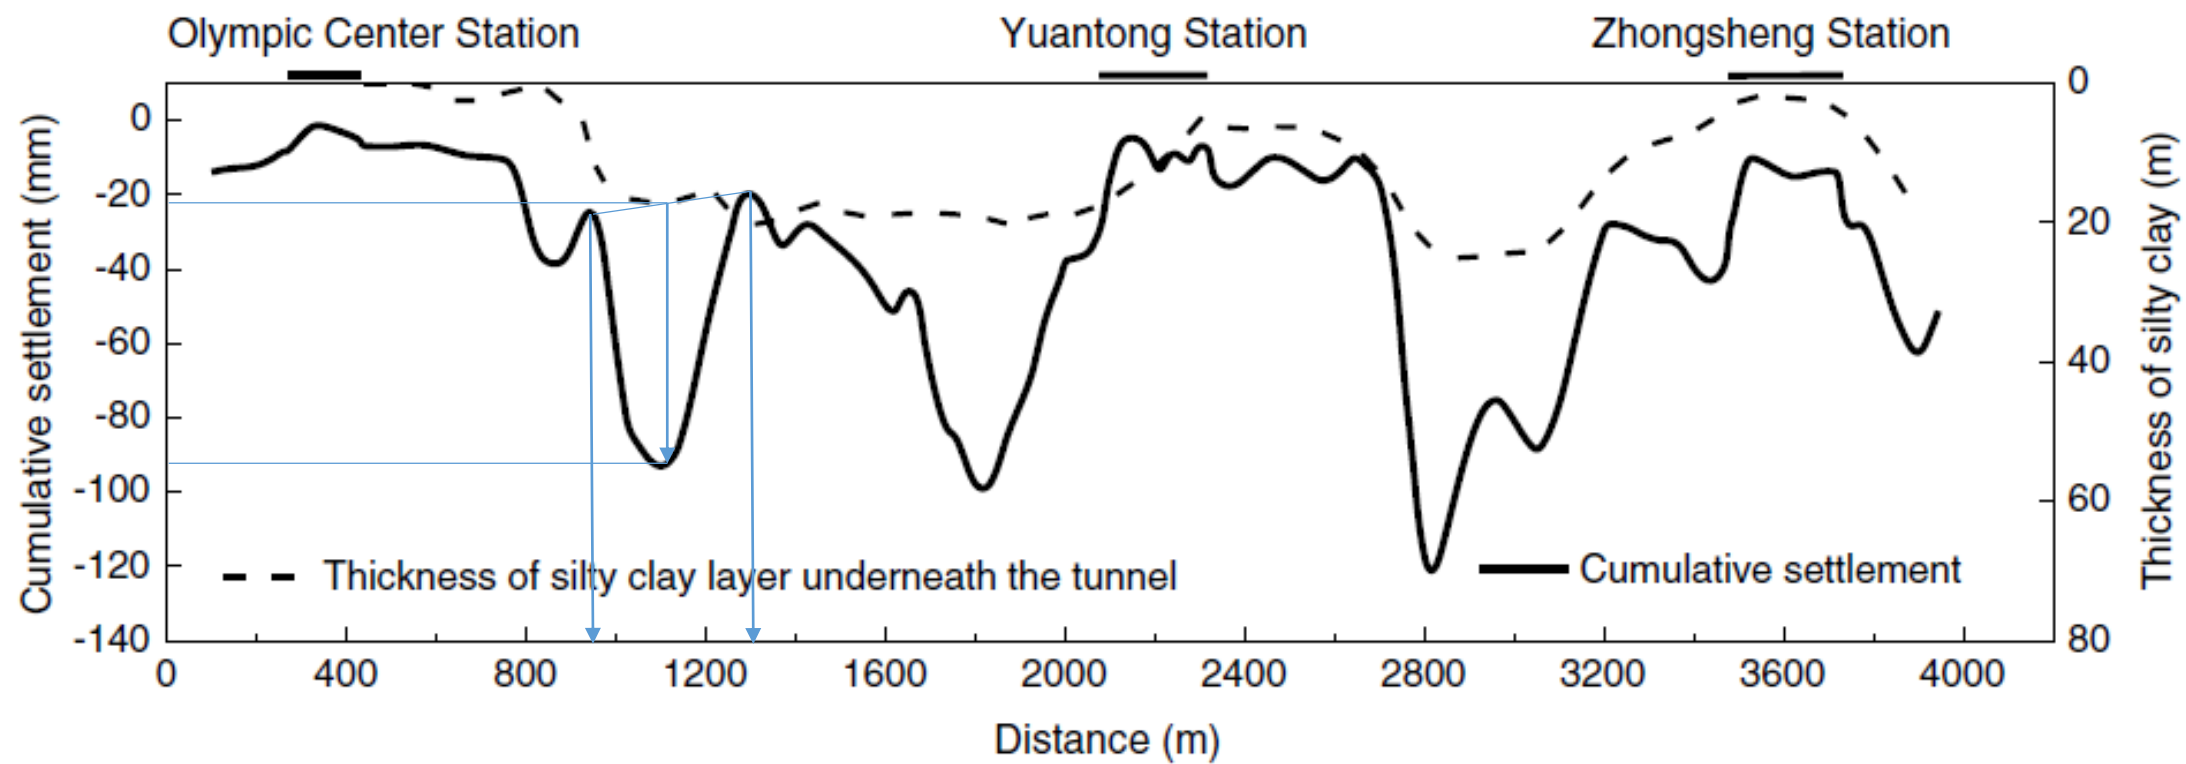
Η επιβαλλόμενη καμπυλότητα στη σήραγγα, προκύπτει ως:

$$\leftarrow L = 1320 - 880 = 440 \text{ (m)} \rightarrow$$

$$\delta = 94 - 22 = 72 \text{ mm}$$

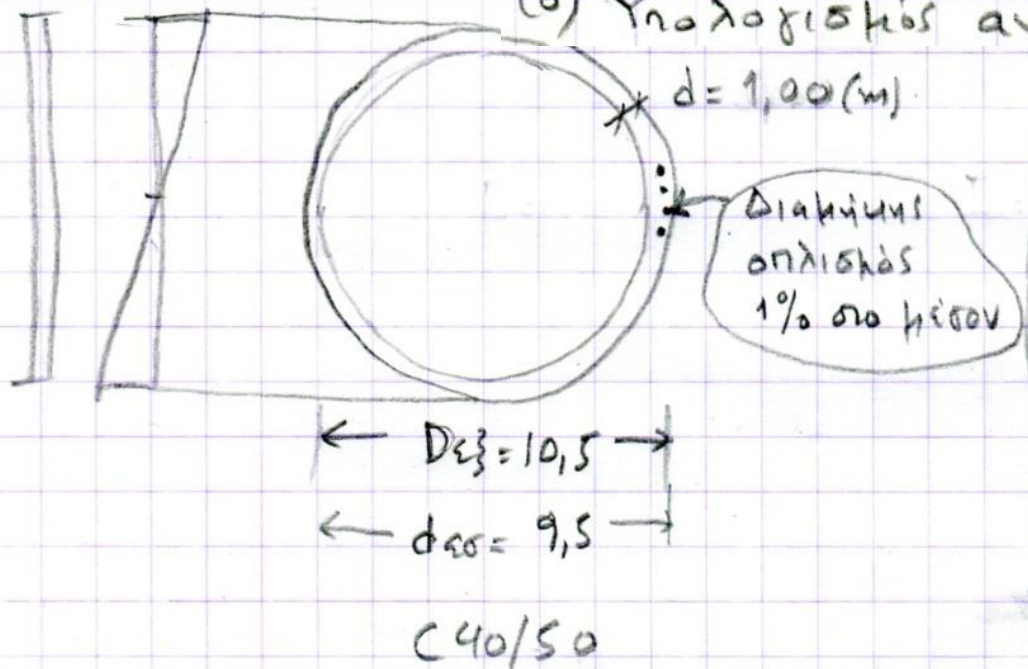
$$\frac{1}{R_{σααε}} = \frac{\epsilon_{ε1} + \epsilon_{ε2}}{d} = \frac{2 \cdot 8,33 \cdot 10^{-6}}{10,5}$$

$$= \underline{1,59 \cdot 10^{-6} \text{ m}^{-1}} < 3 \cdot 10^{-6} \text{ m}^{-1}$$

Άρα η διαστολή έχει ρηχιατωθεί στην εφελκυστική περιοχή, λόγω υαίκτης.
